**Washington State Ferries**  
**Report of Formal Investigation**  
**M/V Walla Walla Grounding Incident**  
**15 April 2023**

**James Schubert, Washington State Ferries Maintenance & Operations Port Engineer**

**Beth Stowell, Washington State Ferries Crew Resource Manager**

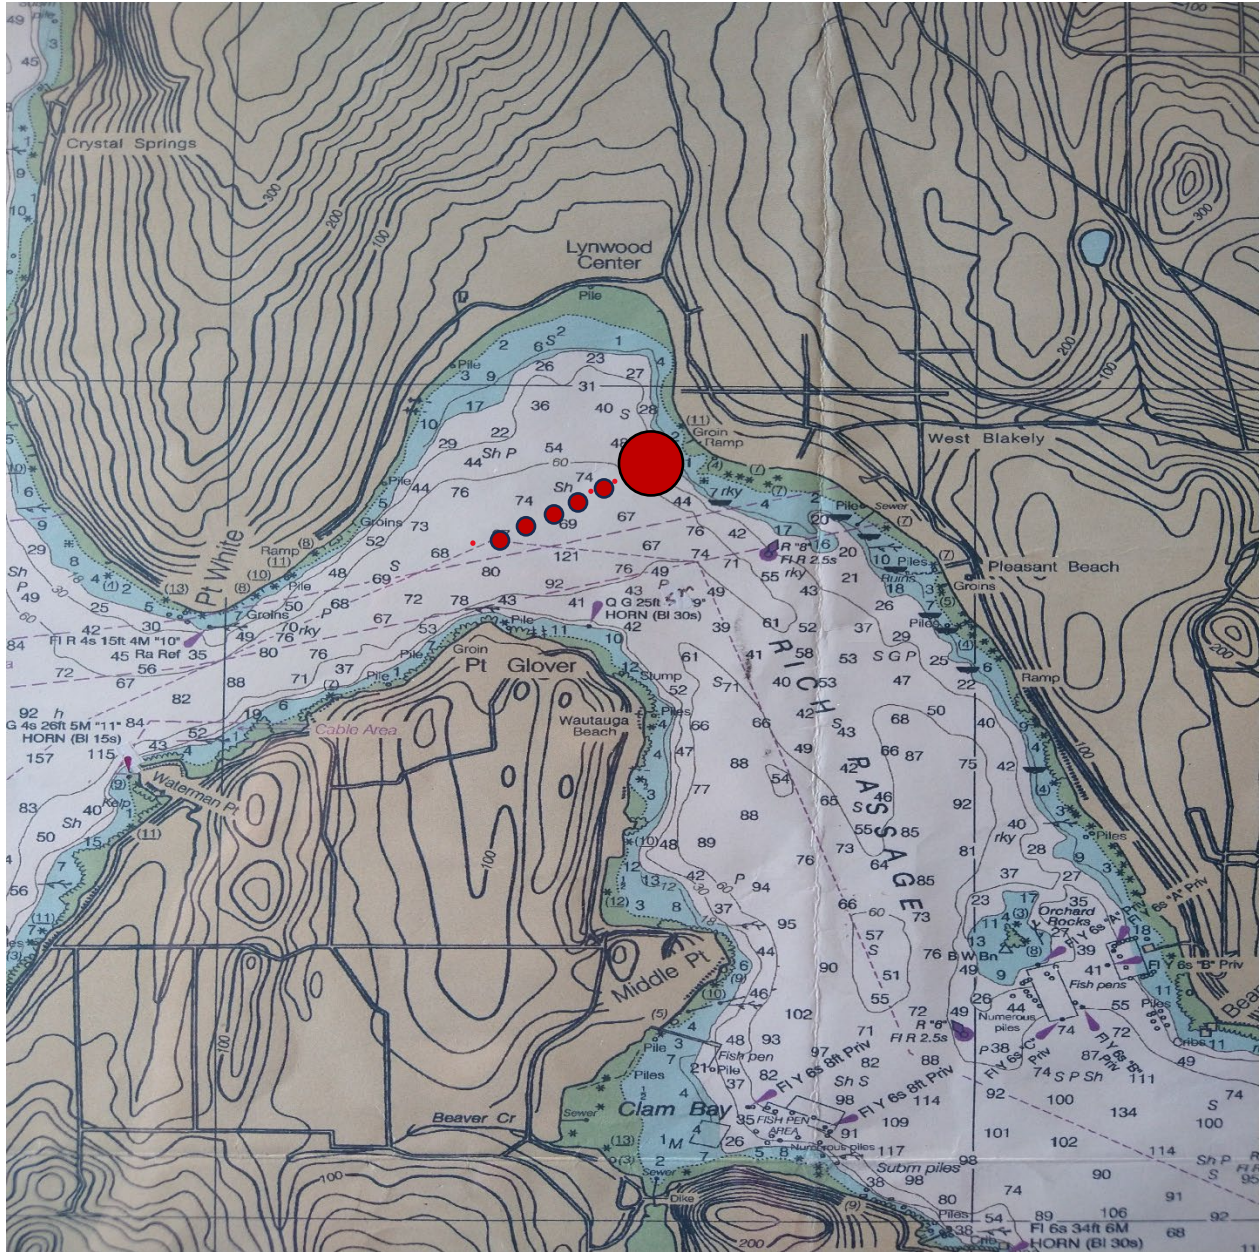
Appendix 3 - Walla Walla Course

Nautical Chart of Rich Passage between Bainbridge Island and Port Orchard. The red dots abeam of Pt. Glover put the vessel on a course of 060° T and shows the vessel grounding area.

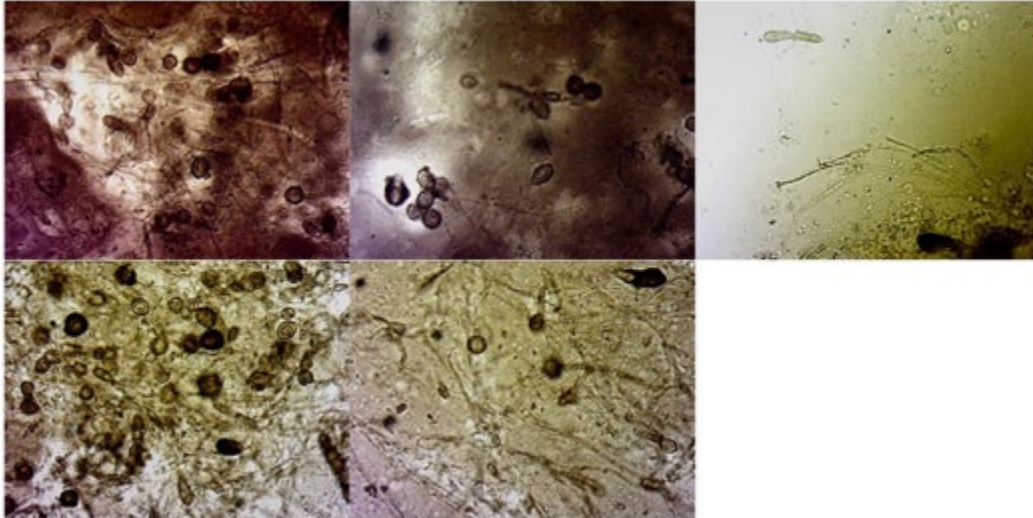
A total of 13 sites were sampled of the in-line filters on the ships service diesel generator and the vital generator. An examination of five of the 13 sites sampled showed bacterial or fungal growth as noted below.

Sample testing comments:

- Thick dark sludge is composed of microbial structures (primarily fungus) and metallic debris.
- Aqueous samples contain low levels of chlorine which suggest freshwater contamination.
- Viable microbial growth can take up to seven days.

- **Equipment-Engine:**
  - Requirements for the inspection and recording of maintenance of both day tanks annually to ensure they are free of contamination.

- Find and correct the source of air entry into the primary filters.
  - Redesign the low point drain for the day tanks for better water removal.
  - Increase the dosage amount of fuel biocide (vessel has been using the brand BIOBOR).

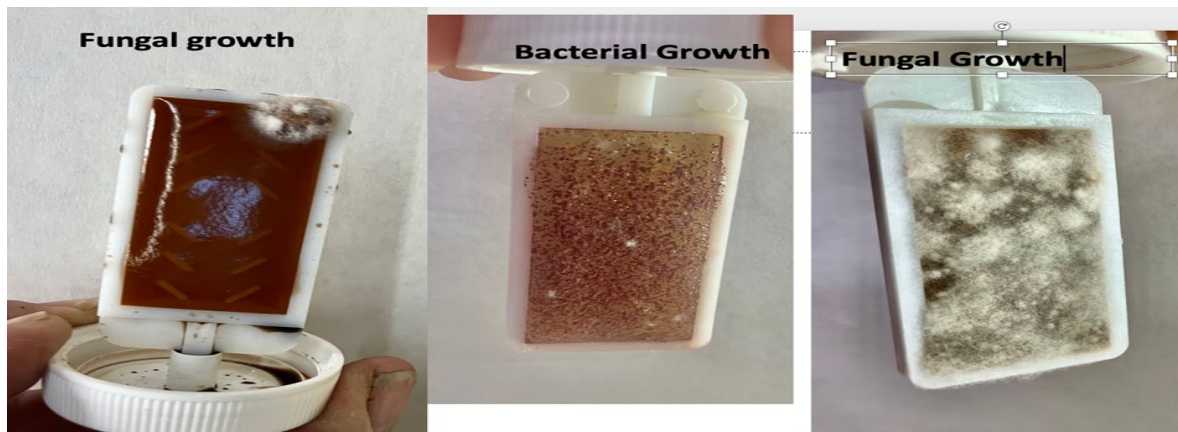
Additional measures were taken, with the results of the samples grown on sterile medium as pictured below.
