APPENDIX A

Stormwater Management Memorandum

This memorandum presents proposed stormwater management strategies for the Columbia River Crossing (CRC) project. Figure 1 shows the proposed footprint and location of Ruby Junction, the proposed site for the light rail vehicle (LRV) maintenance facility. The memo does not provide an evaluation of the potential impacts from the strategies; these are addressed in the Biological Assessment and Final Environmental Impact Statement (FEIS) Water Quality Technical Report.

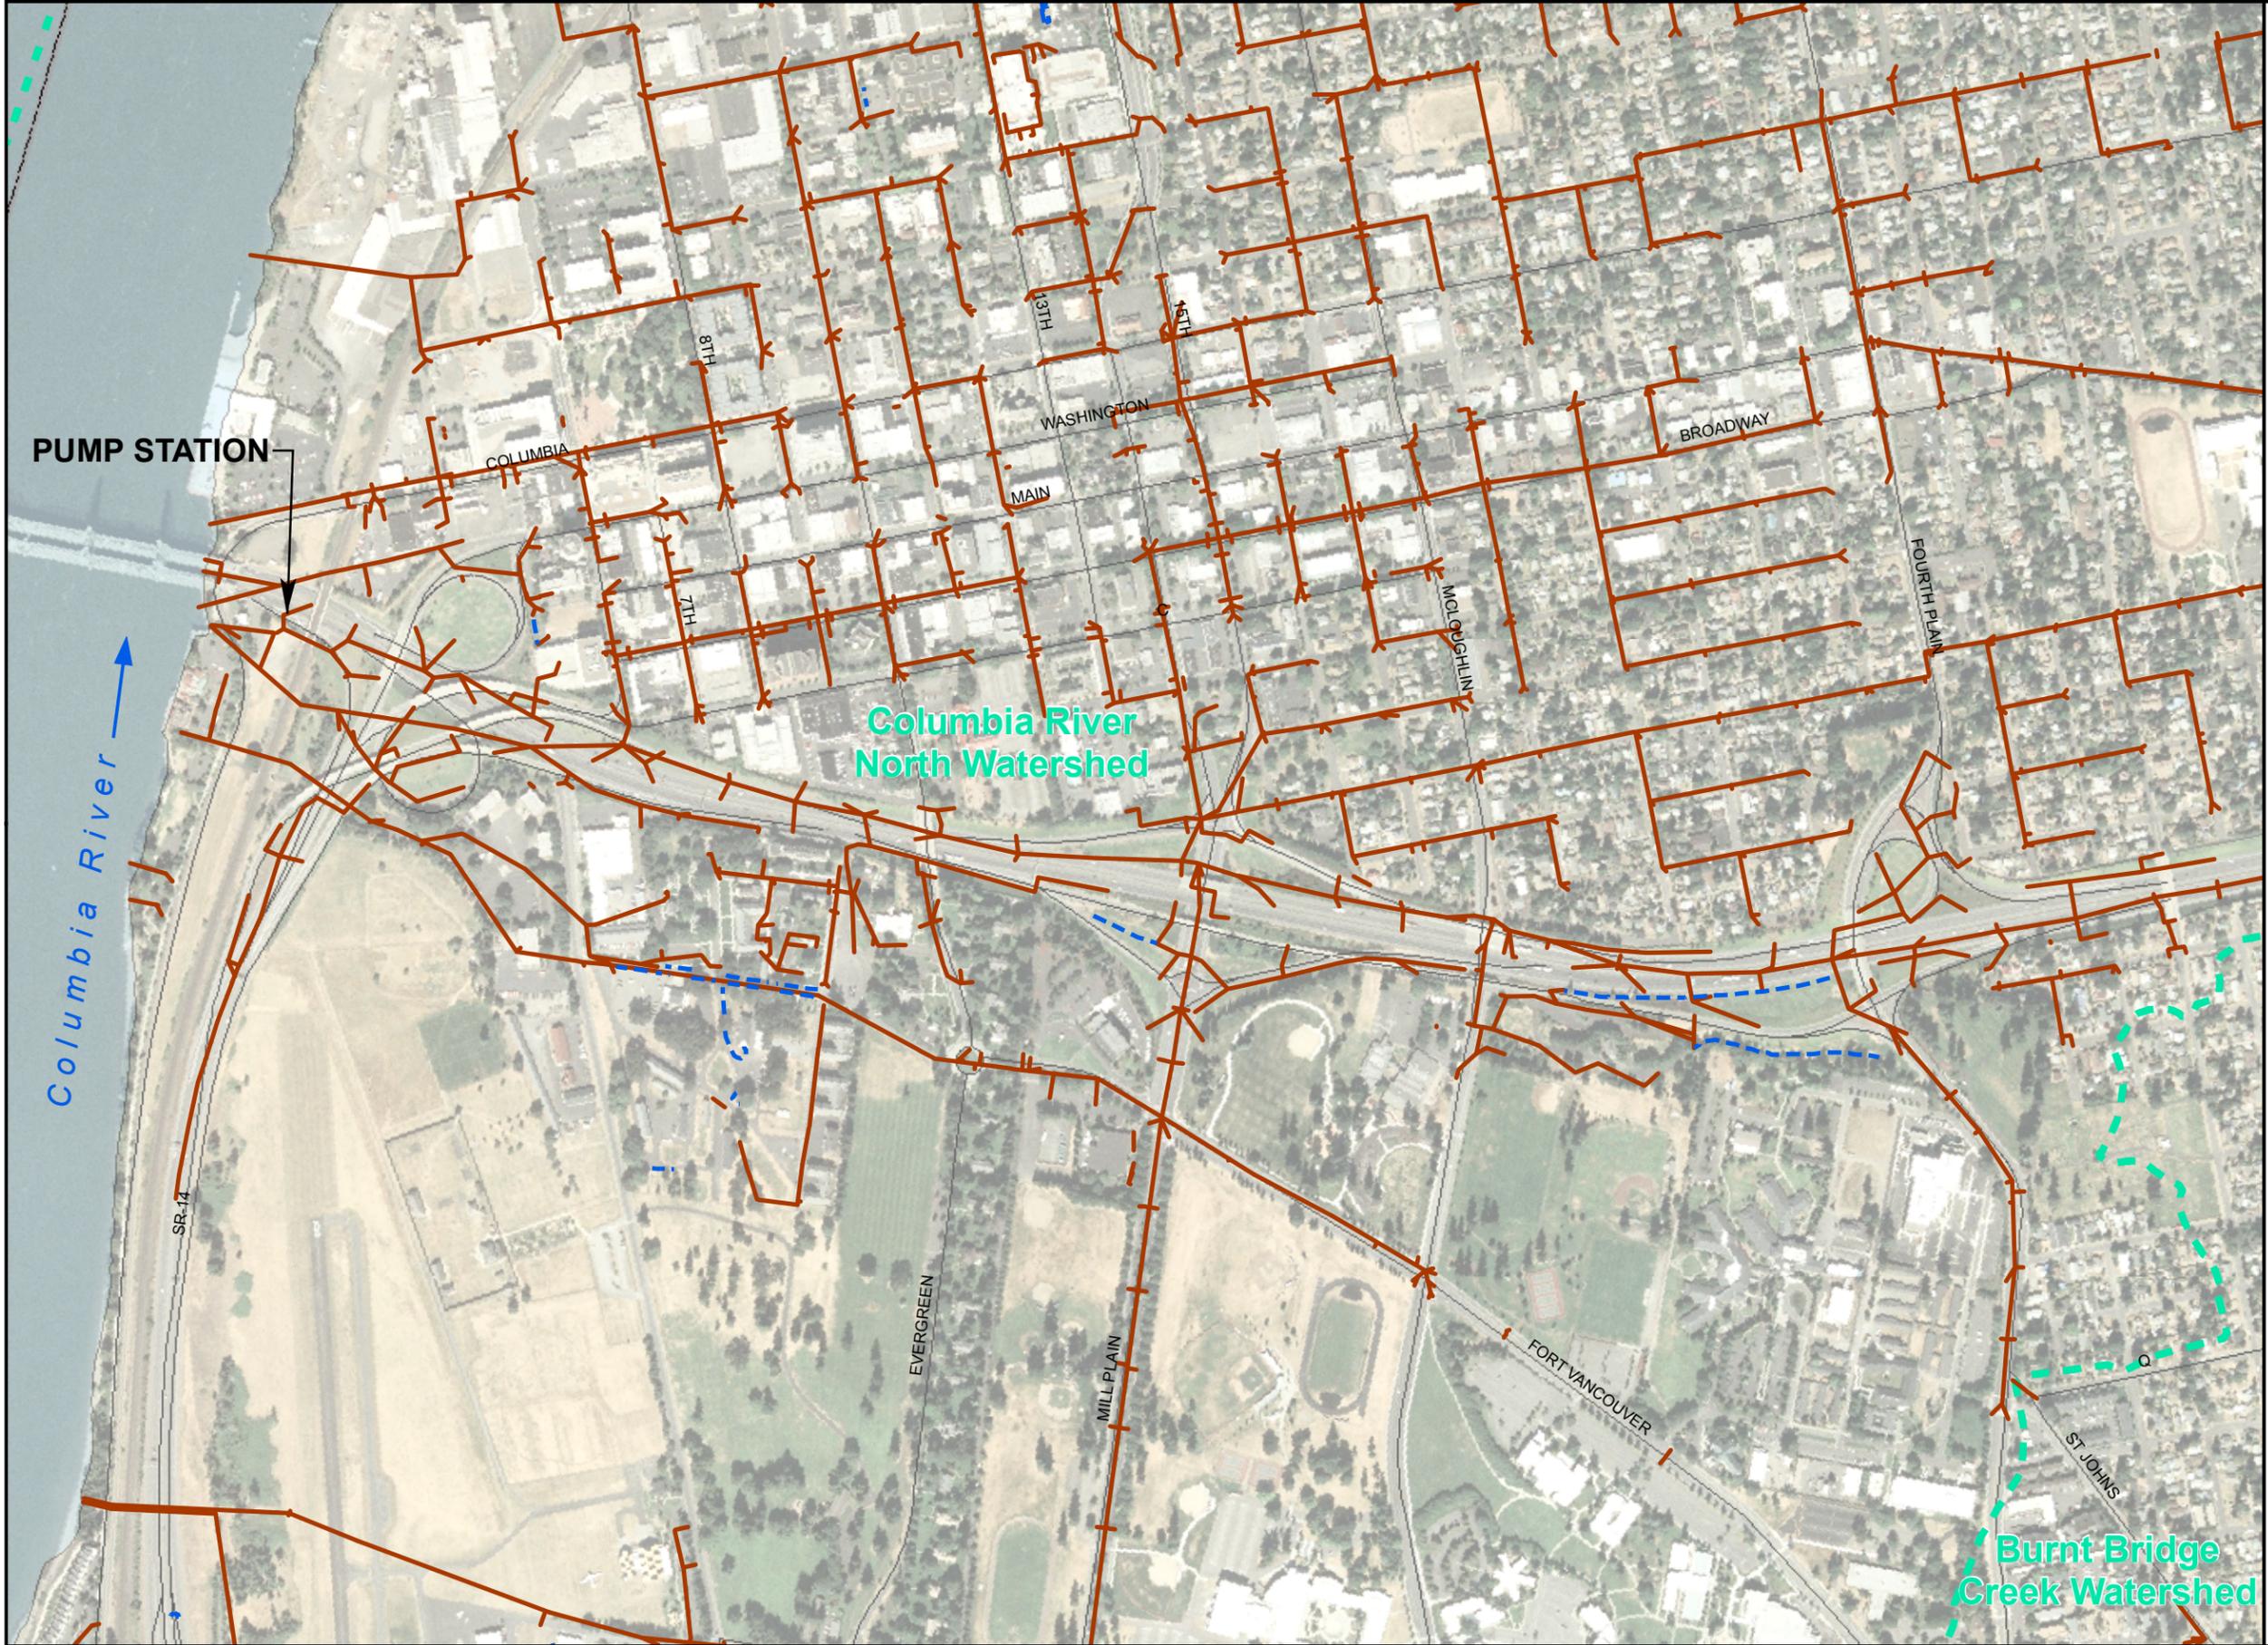
Figure 3.
Existing Conditions - Washington
State (Sheet 1 of 2)

- Natural Watercourse
- - - Drainage Ditch
- Storm Sewer Line
- - - Watershed Boundary

The vertical grade of I-5 is generally below the surrounding areas and as a result, the drainage system serving the highway also handles runoff from built-up areas outside the highway right-of-way as shown on Figures 3 and 4. These areas, which are extensive, are estimated to comprise over 50 percent of the total drainage area served by this system, and their contribution to flows was an important consideration when developing the approach to stormwater management in this watershed.

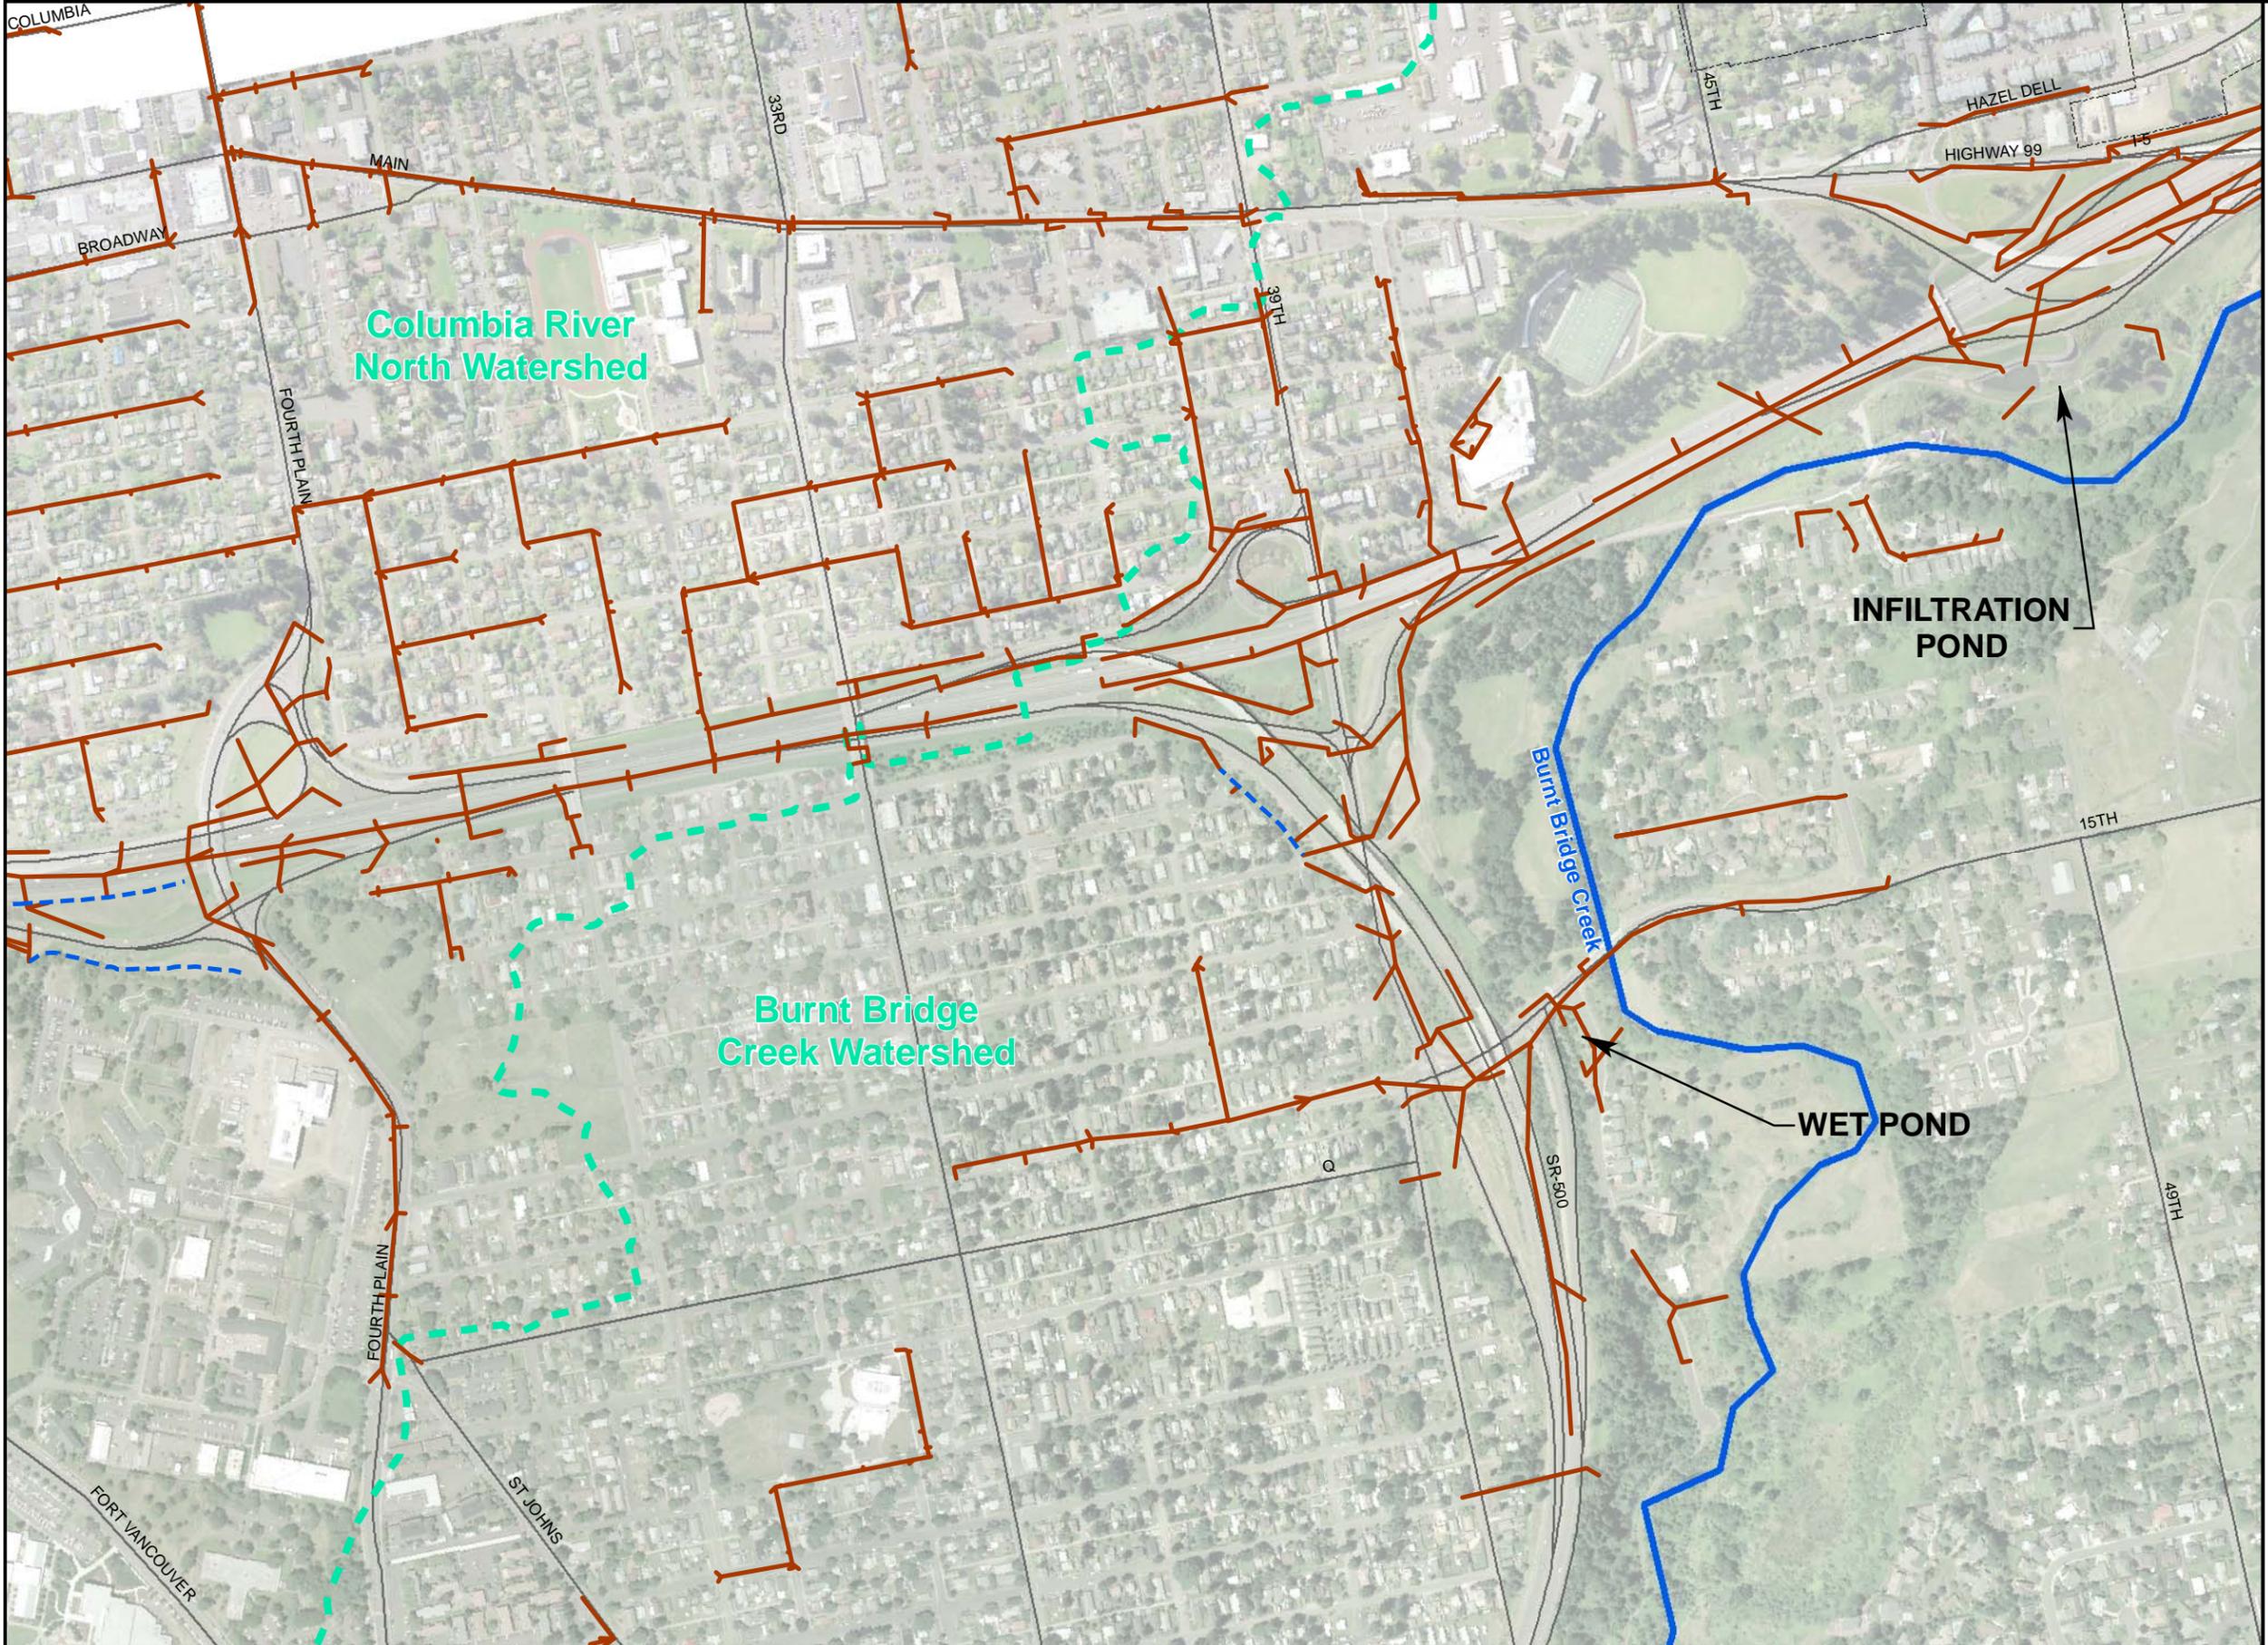
Figure 4.
Existing Conditions - Washington
State (Sheet 2 of 2)

- Natural Watercourse
- - - Drainage Ditch
- Storm Sewer Line
- - - Watershed Boundary

Typical of an urban environment, surface runoff from the highways and local streets is generally confined to the roadway by continuous curbs and concrete barriers, and is collected almost entirely by closed drainage systems. In contrast to the other watersheds, runoff from the entire PGIS within the project footprint currently contains some form of treatment. Runoff from about 14.5 and 0.2 acres of PGIS and non-PGIS within the project footprint is conveyed to an infiltration pond at the Main Street interchange and the balance is conveyed to a wet pond north of SR 500 (see Figure 4 for both locations).

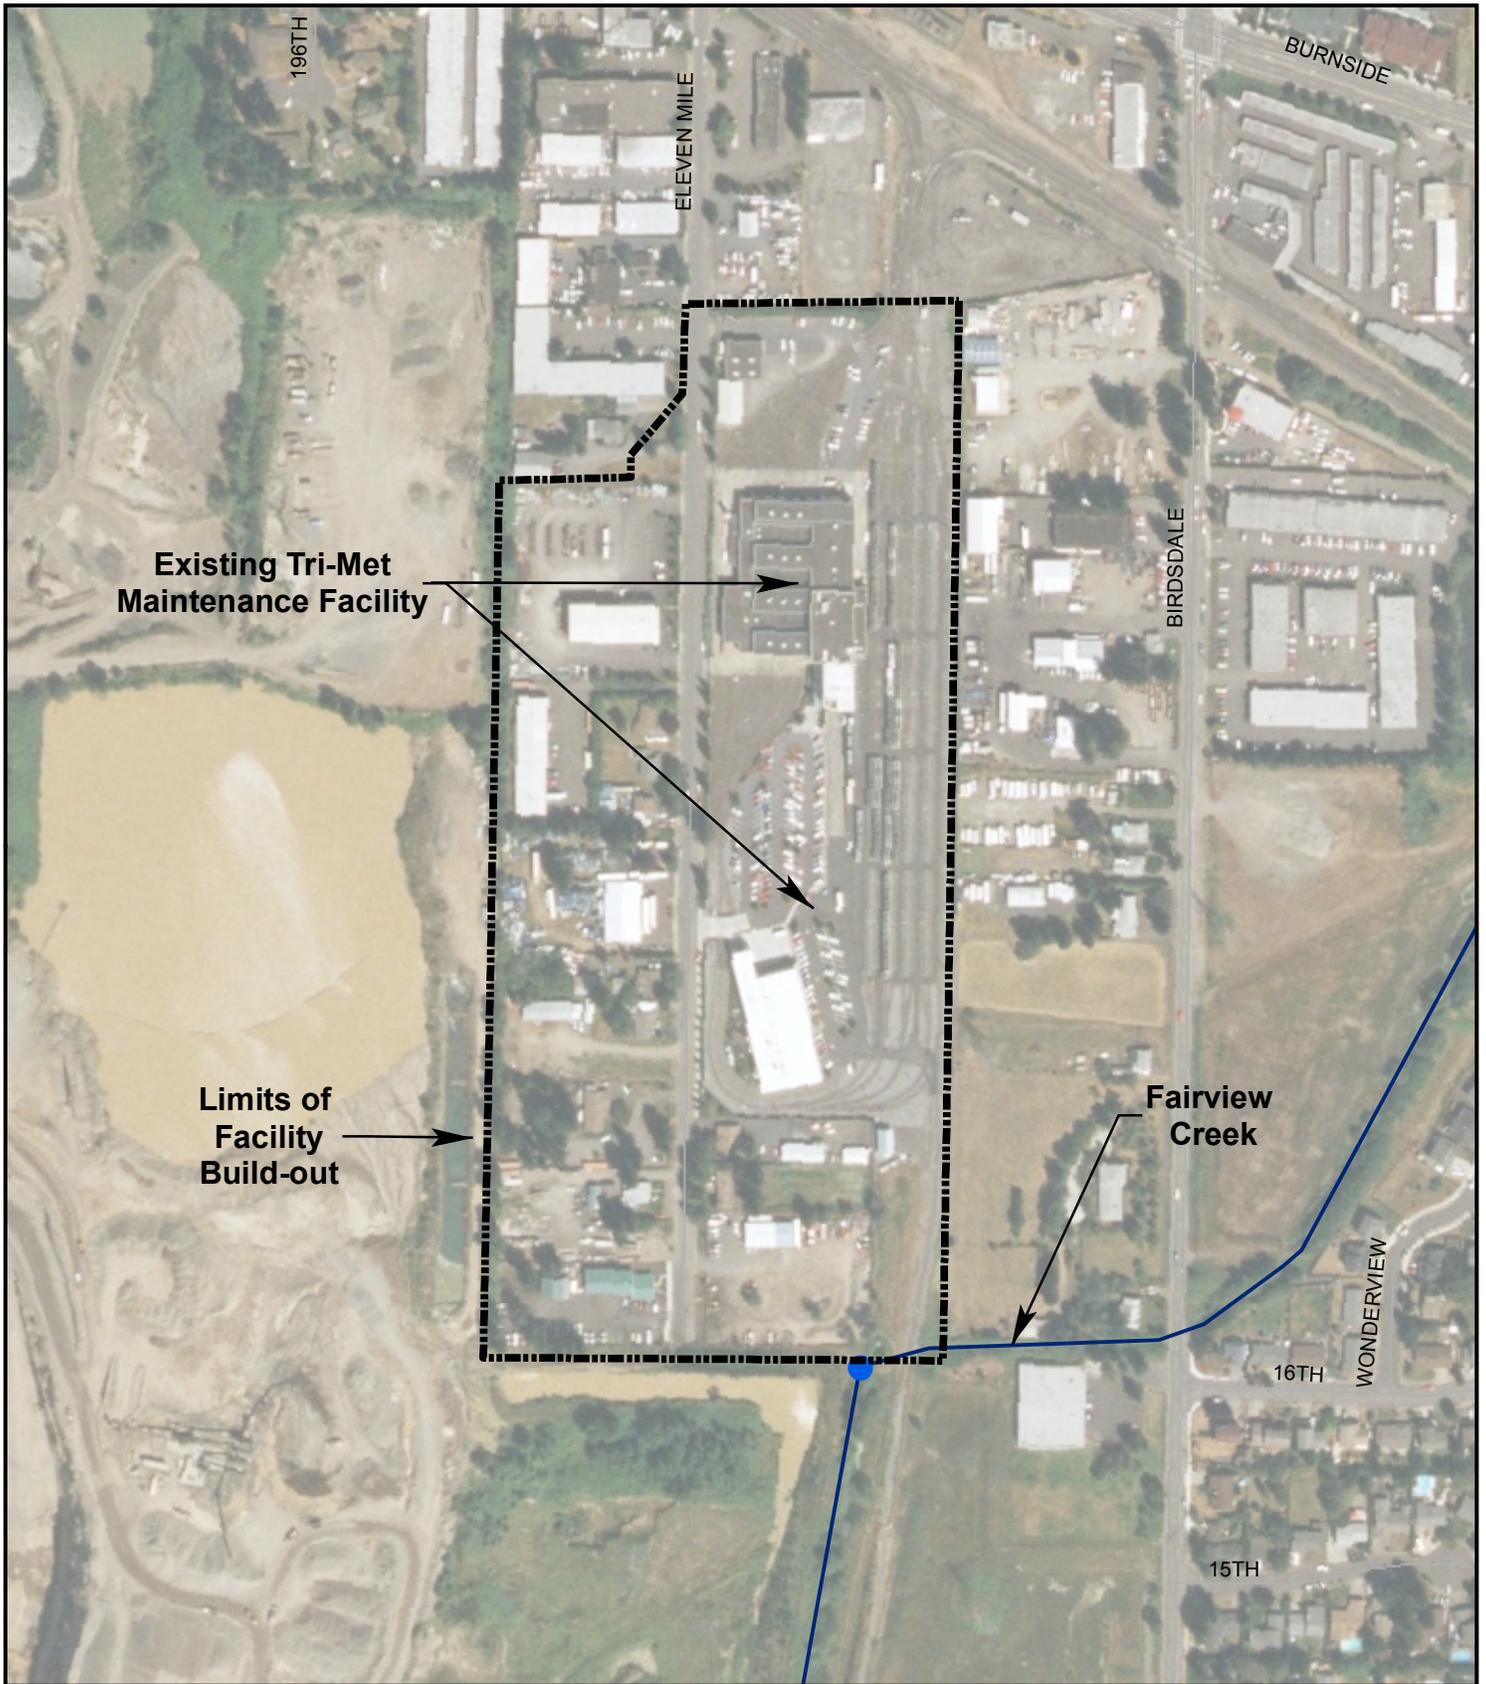
Figure 5.
Threshold Discharge Areas -
Ruby Junction

● Outfalls

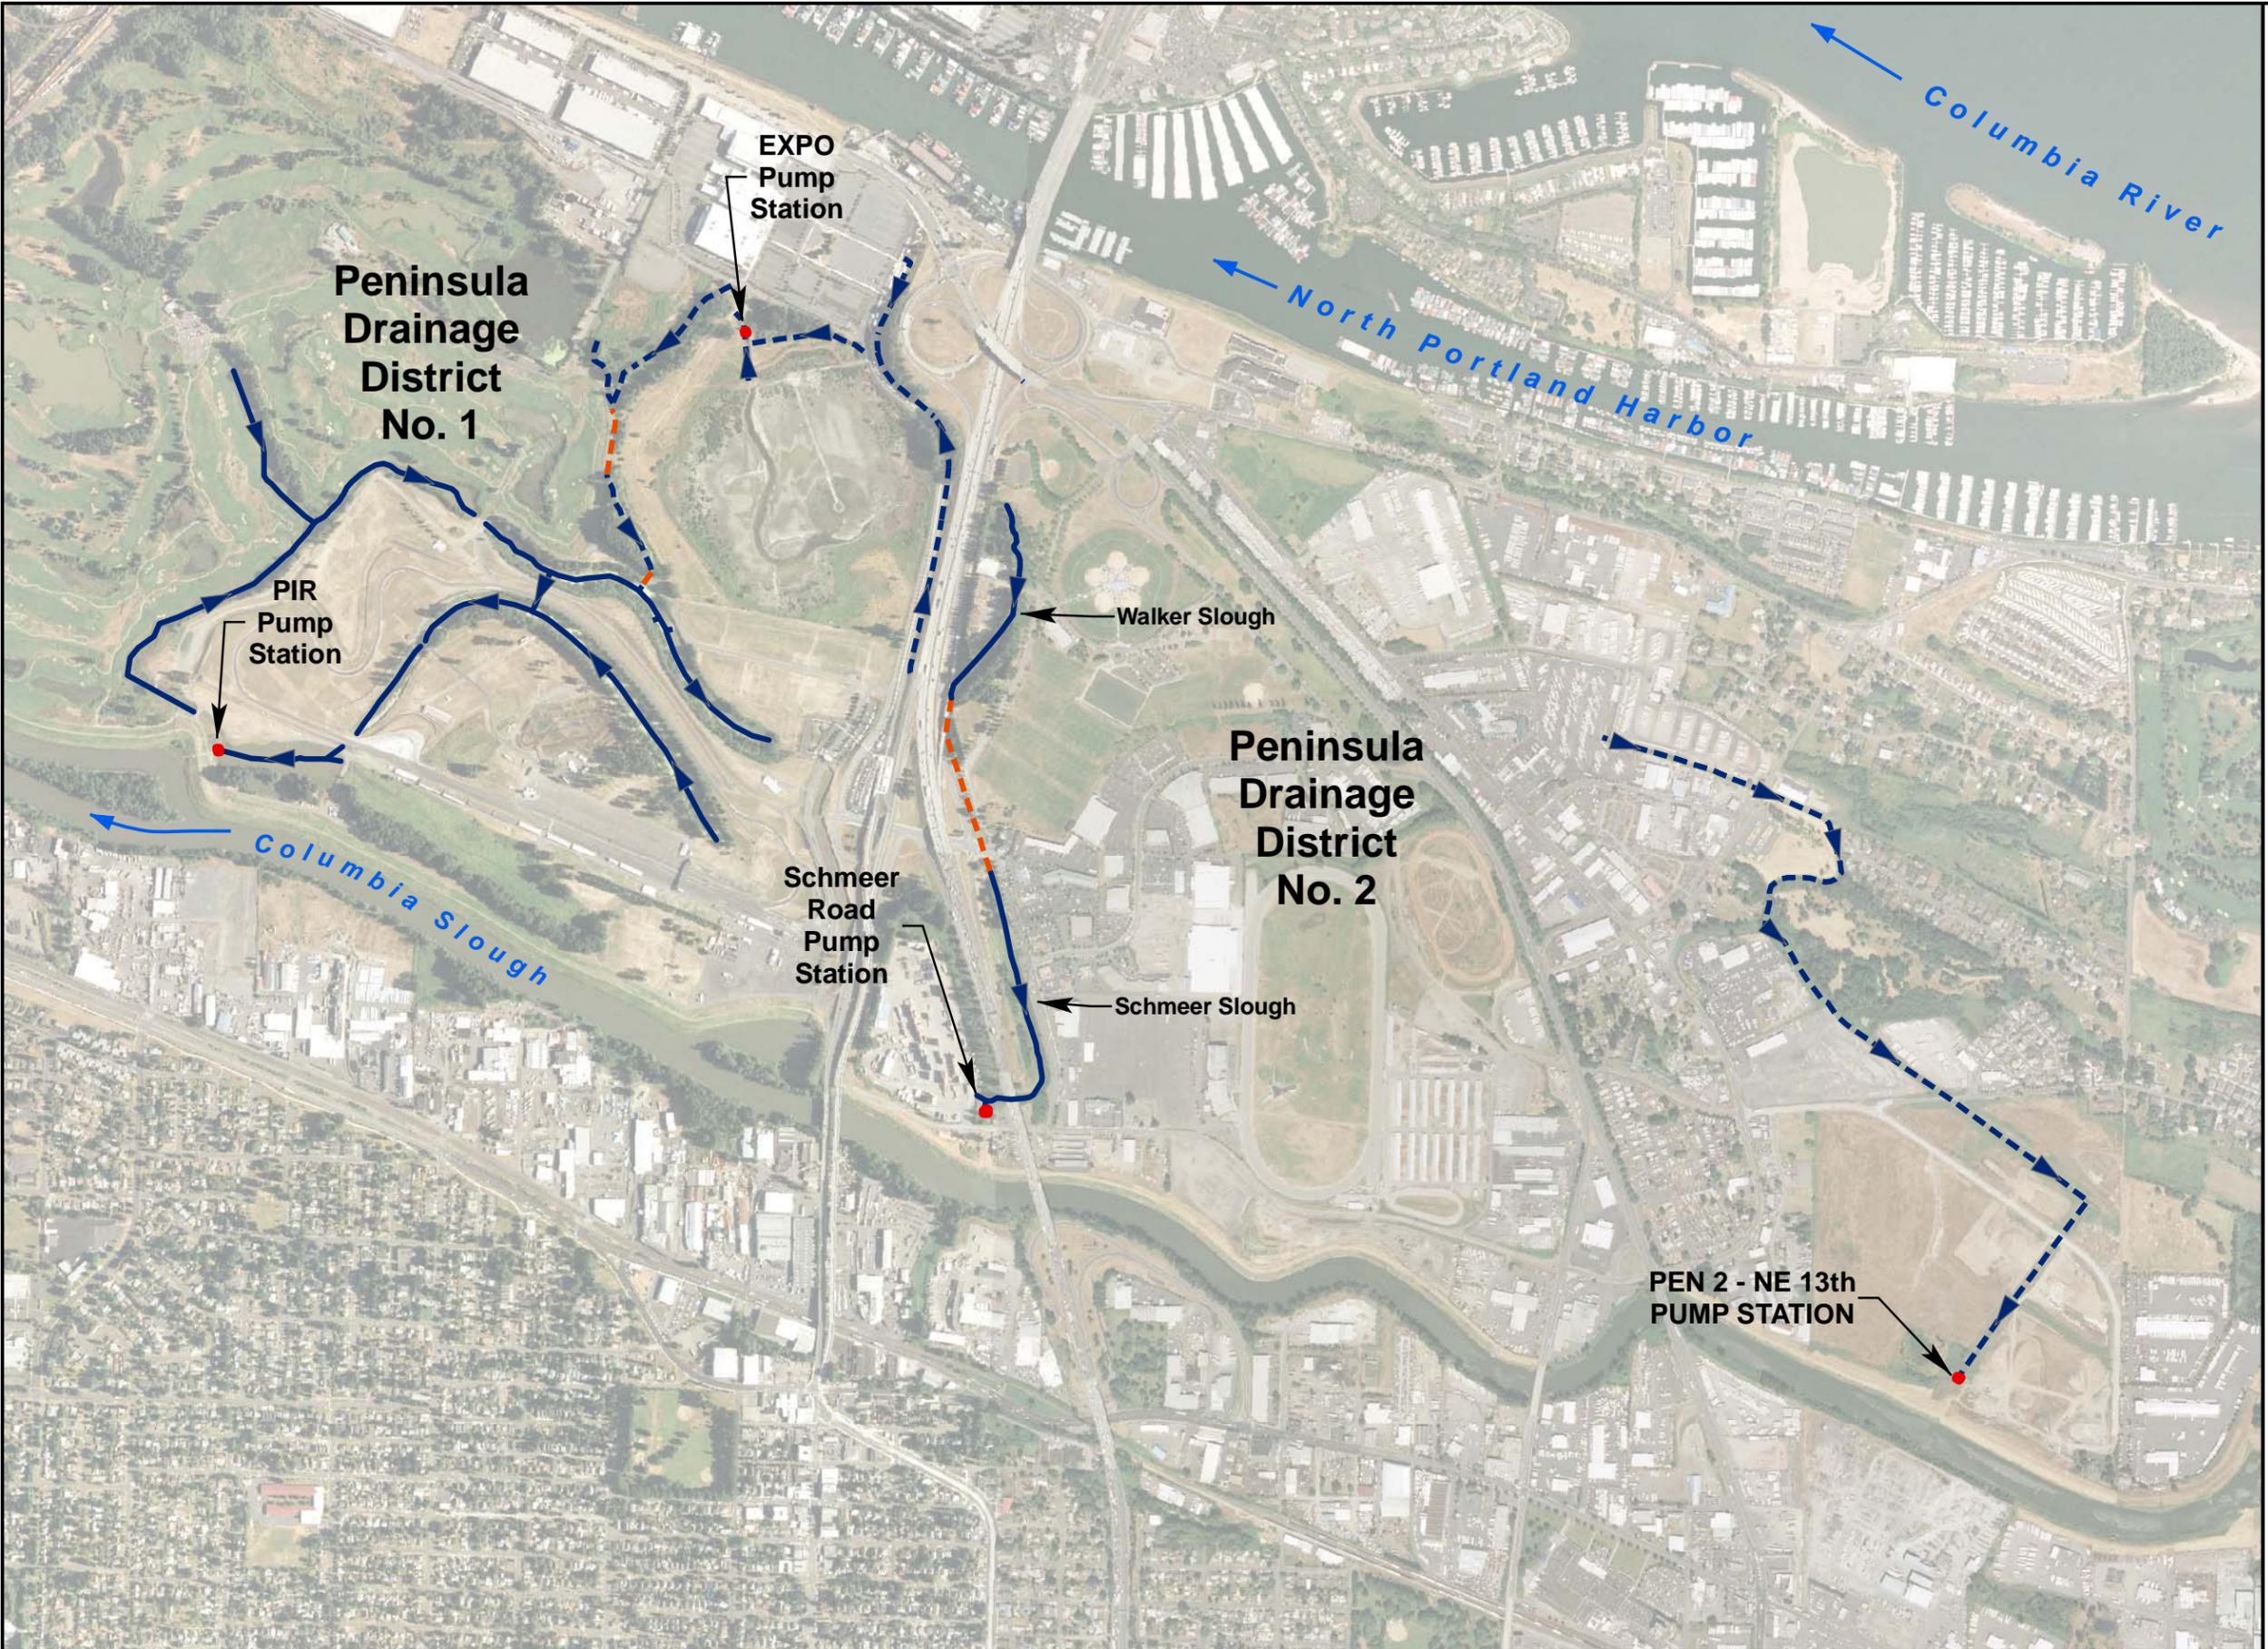
Figure 7.
Surface Water Systems -
Peninsula Drainage Districts

- Natural Watercourse
- - - Drainage Ditch
- - - Culvert
- Pump Station

facility CS-F, adjacent to the connection between MLK and Vancouver Way. Flows from the swale areas would drain to the existing City of Portland stormwater conveyance system under Vancouver Way at outlet CS-06. Additional water quality improvements are expected as runoff flows through over 7,000 feet of open channel before being pumped to Columbia Slough via the Pen 2 – NE 13th Pump Station (see Figure 7).

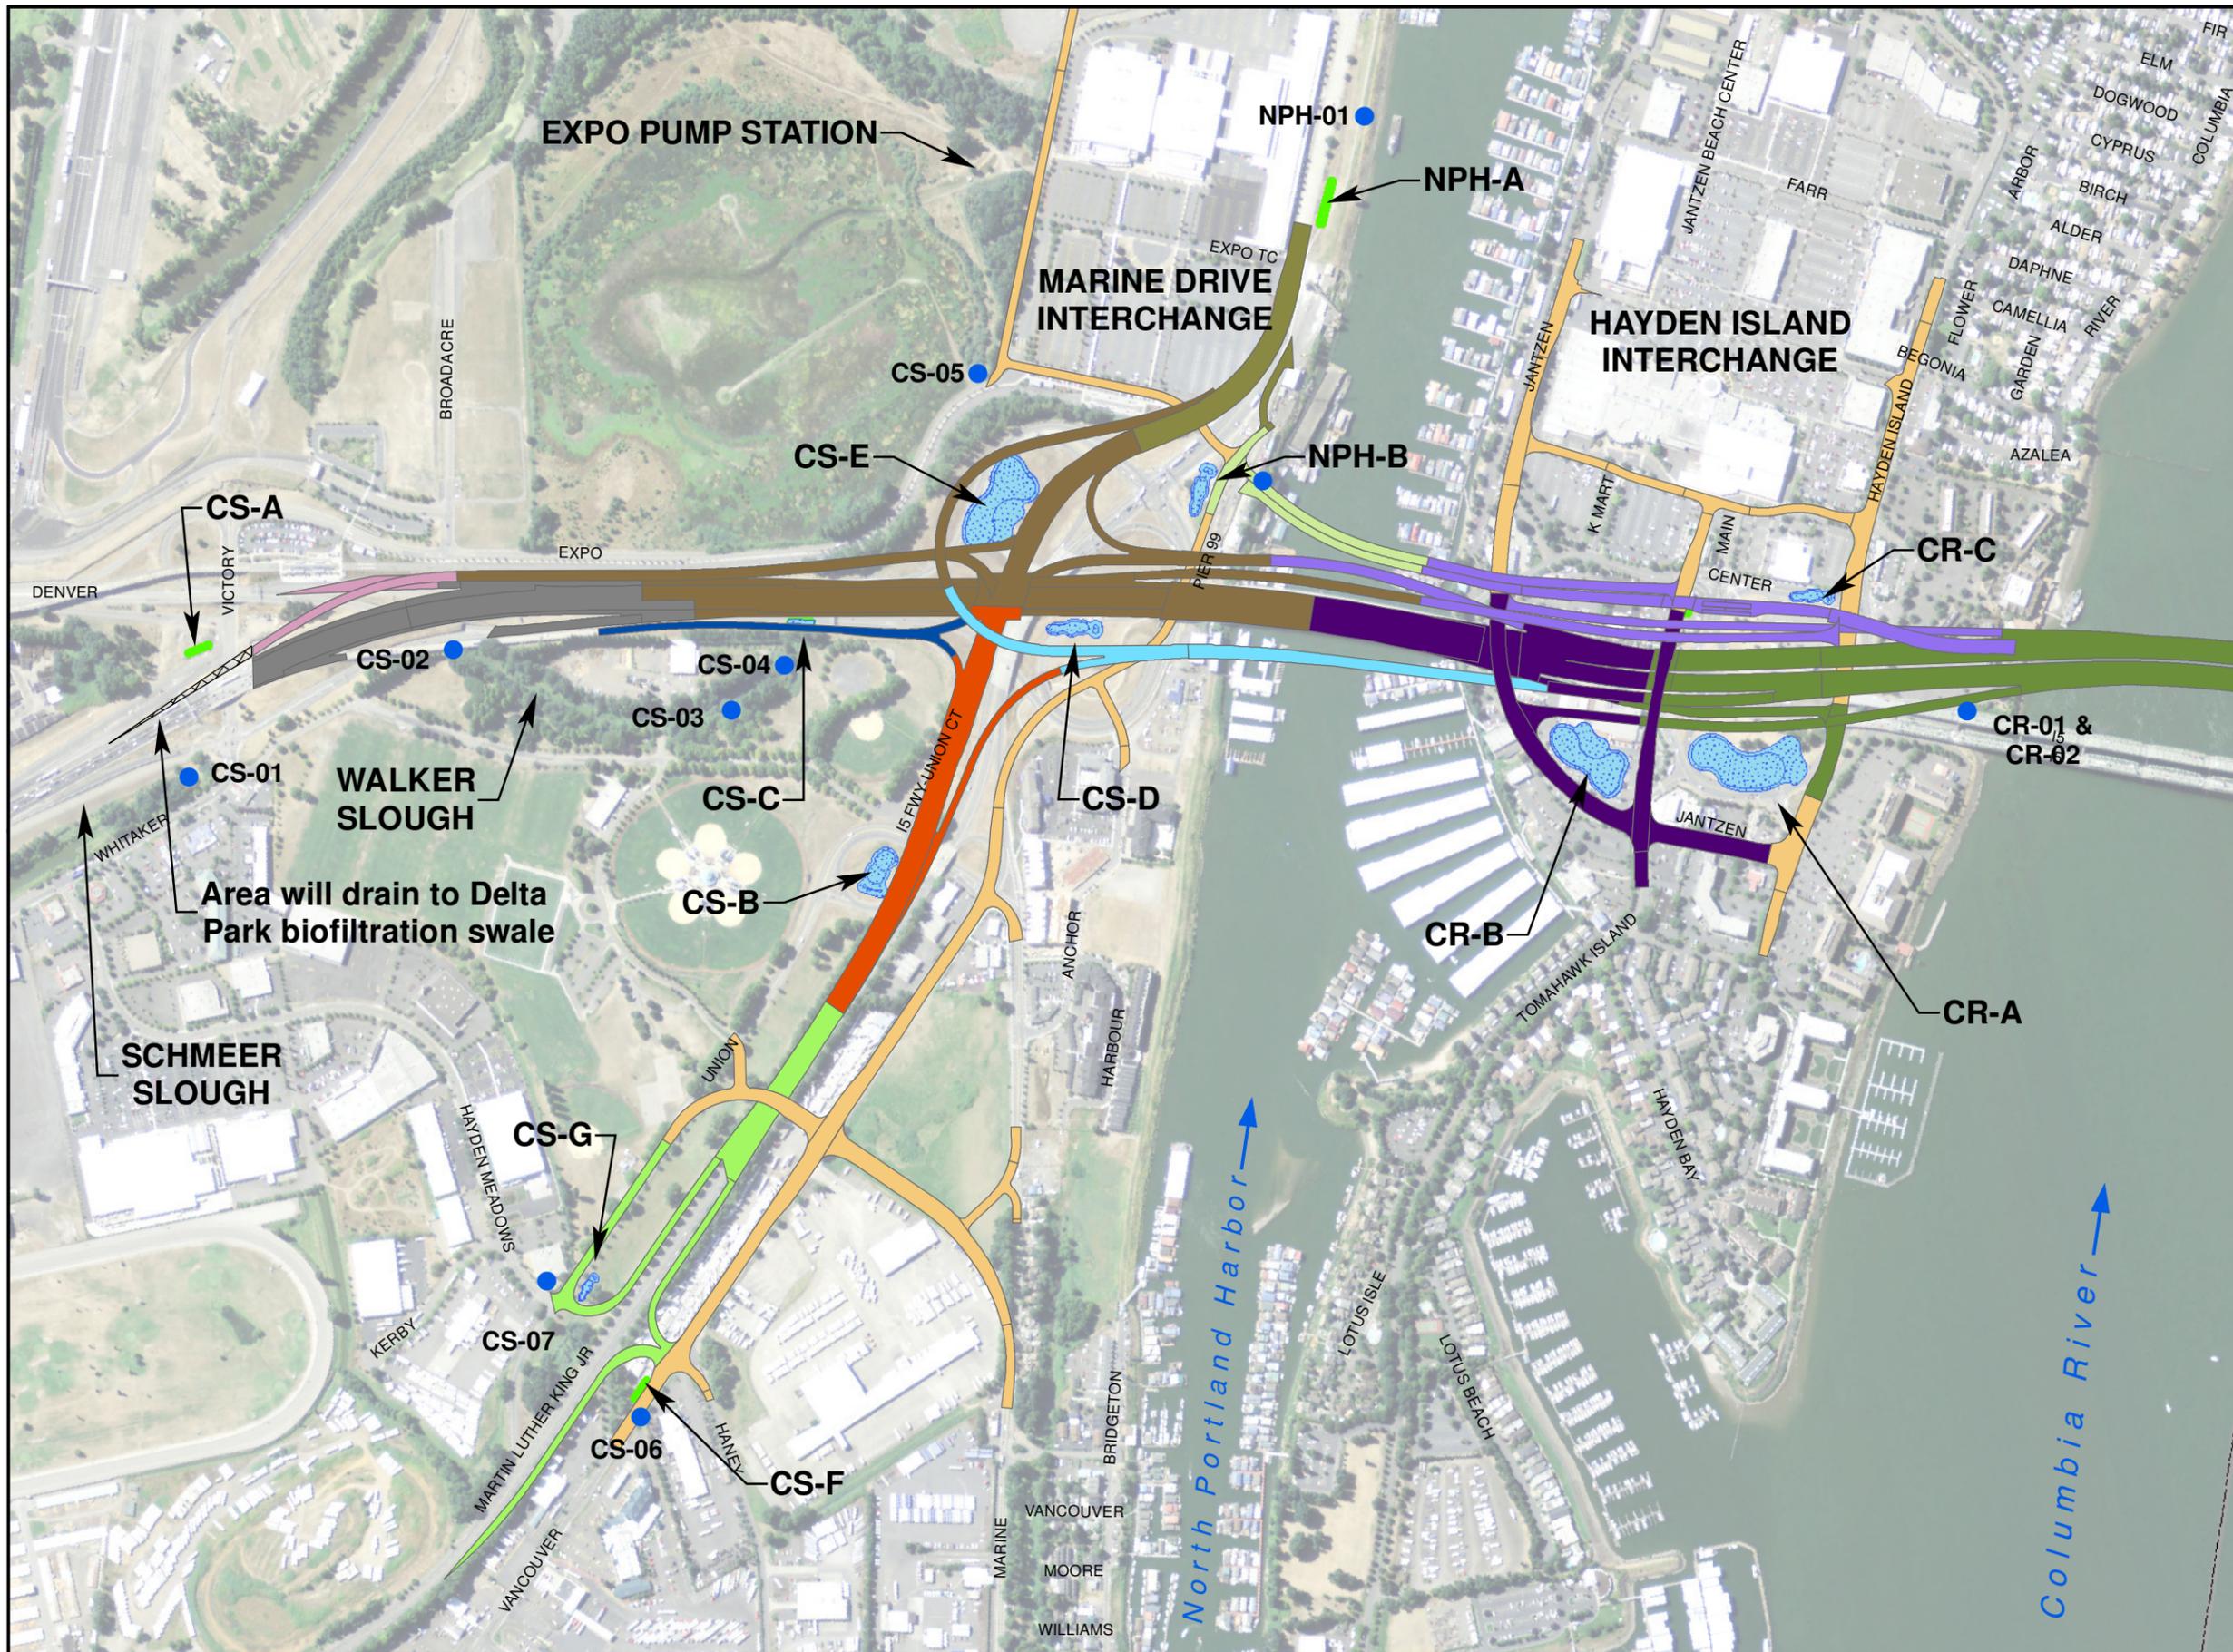
Figure 10.
Proposed Water Management
Facilities - Washington State
(1 of 2)

Areas Draining to Water Quality Facilities

- CR-A
- CR-B
- CR-C
- CS-A
- CS-B
- CS-C
- CS-D
- CS-E
- CS-G
- CS-F
- NPH-A
- NPH-B
- Semi-Continuous Biofiltration Swales or Proprietary Systems
- Not Treated

Table 5 summarizes the impact of the project on CIA and the areas from which runoff will be treated, and the paragraphs following the table describe the individual water quality facilities, the locations of which are shown on Figures 10 and 11.

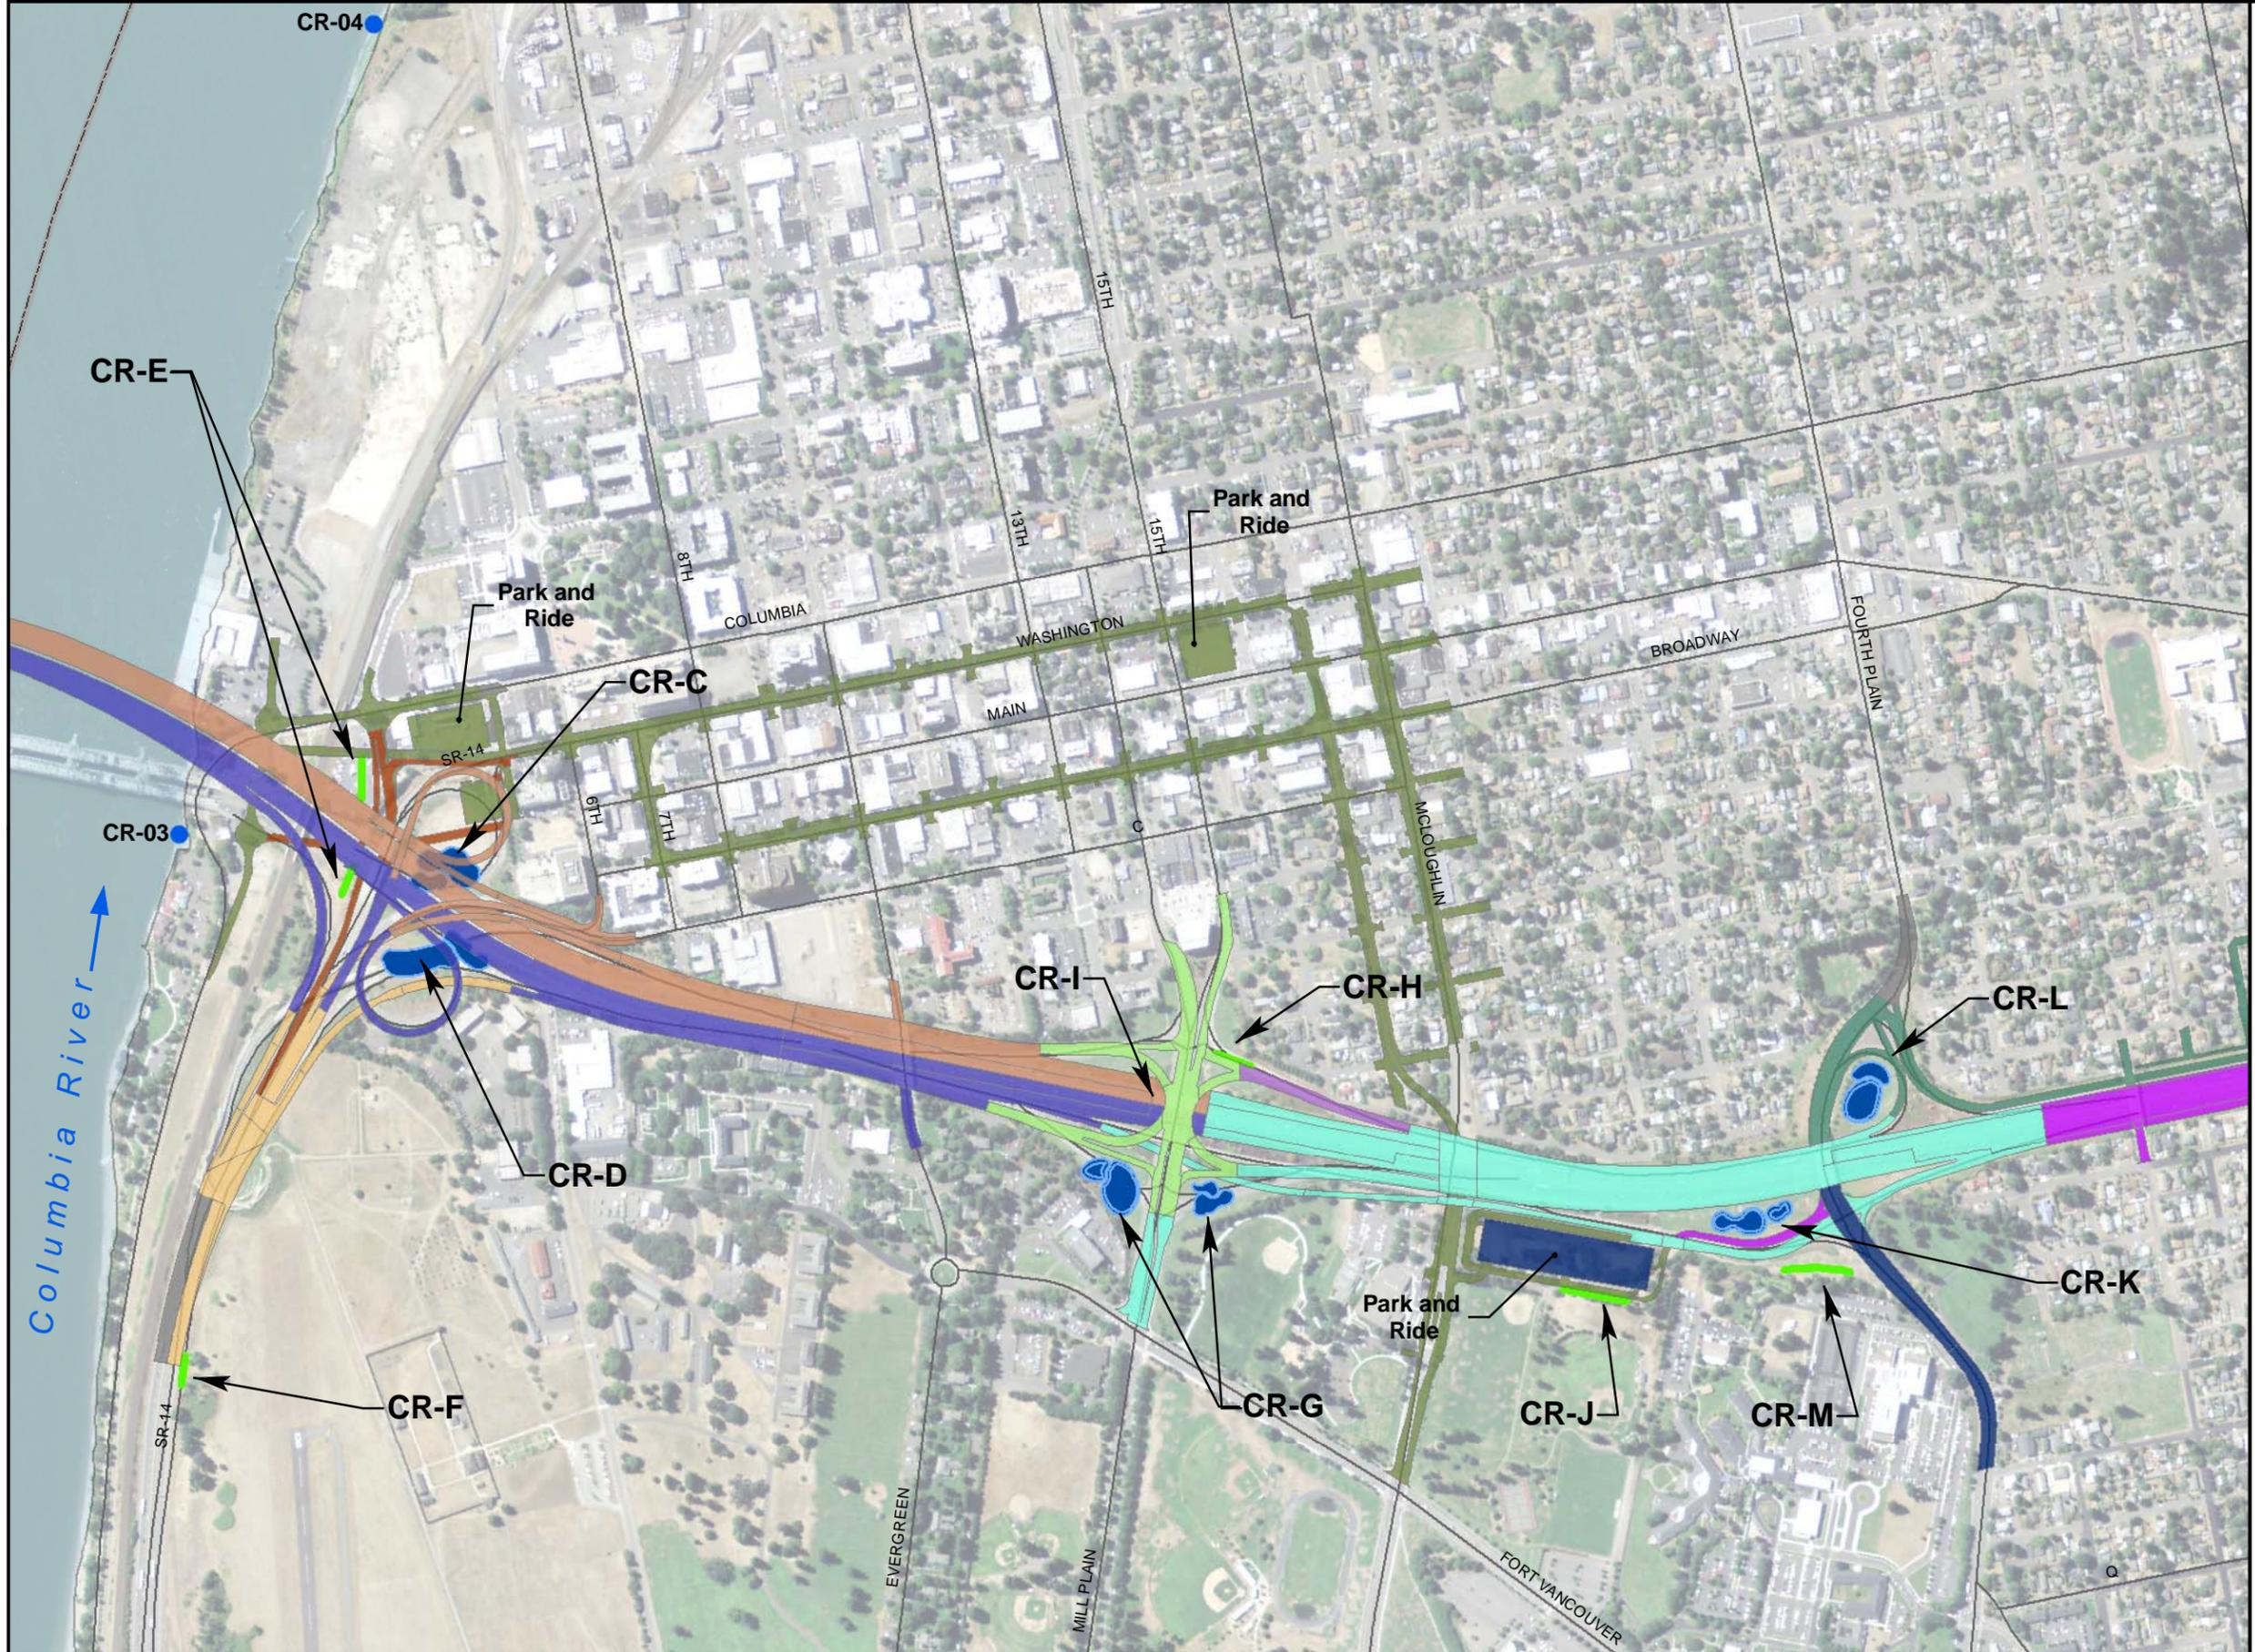
Areas Draining to Water Quality Facilities

- CR-C
- CR-D
- CR-E
- CR-F
- CR-G
- CR-H
- CR-I
- CR-J & CR-M
- CR-K
- CR-L
- Semi-Continuous Biofiltration Swales or Proprietary Systems
- Not Treated

Stormwater Facility Type

- Biofiltration Swale
- Bioretention Pond
- Outfall
