APPENDIX A

Stormwater Management Memorandum

This memorandum presents proposed stormwater management strategies for the Columbia River Crossing (CRC) project. Figure 1 shows the proposed footprint and location of Ruby Junction, the proposed site for the light rail vehicle (LRV) maintenance facility. The memo does not provide an evaluation of the potential impacts from the strategies; these are addressed in the Biological Assessment and Final Environmental Impact Statement (FEIS) Water Quality Technical Report.

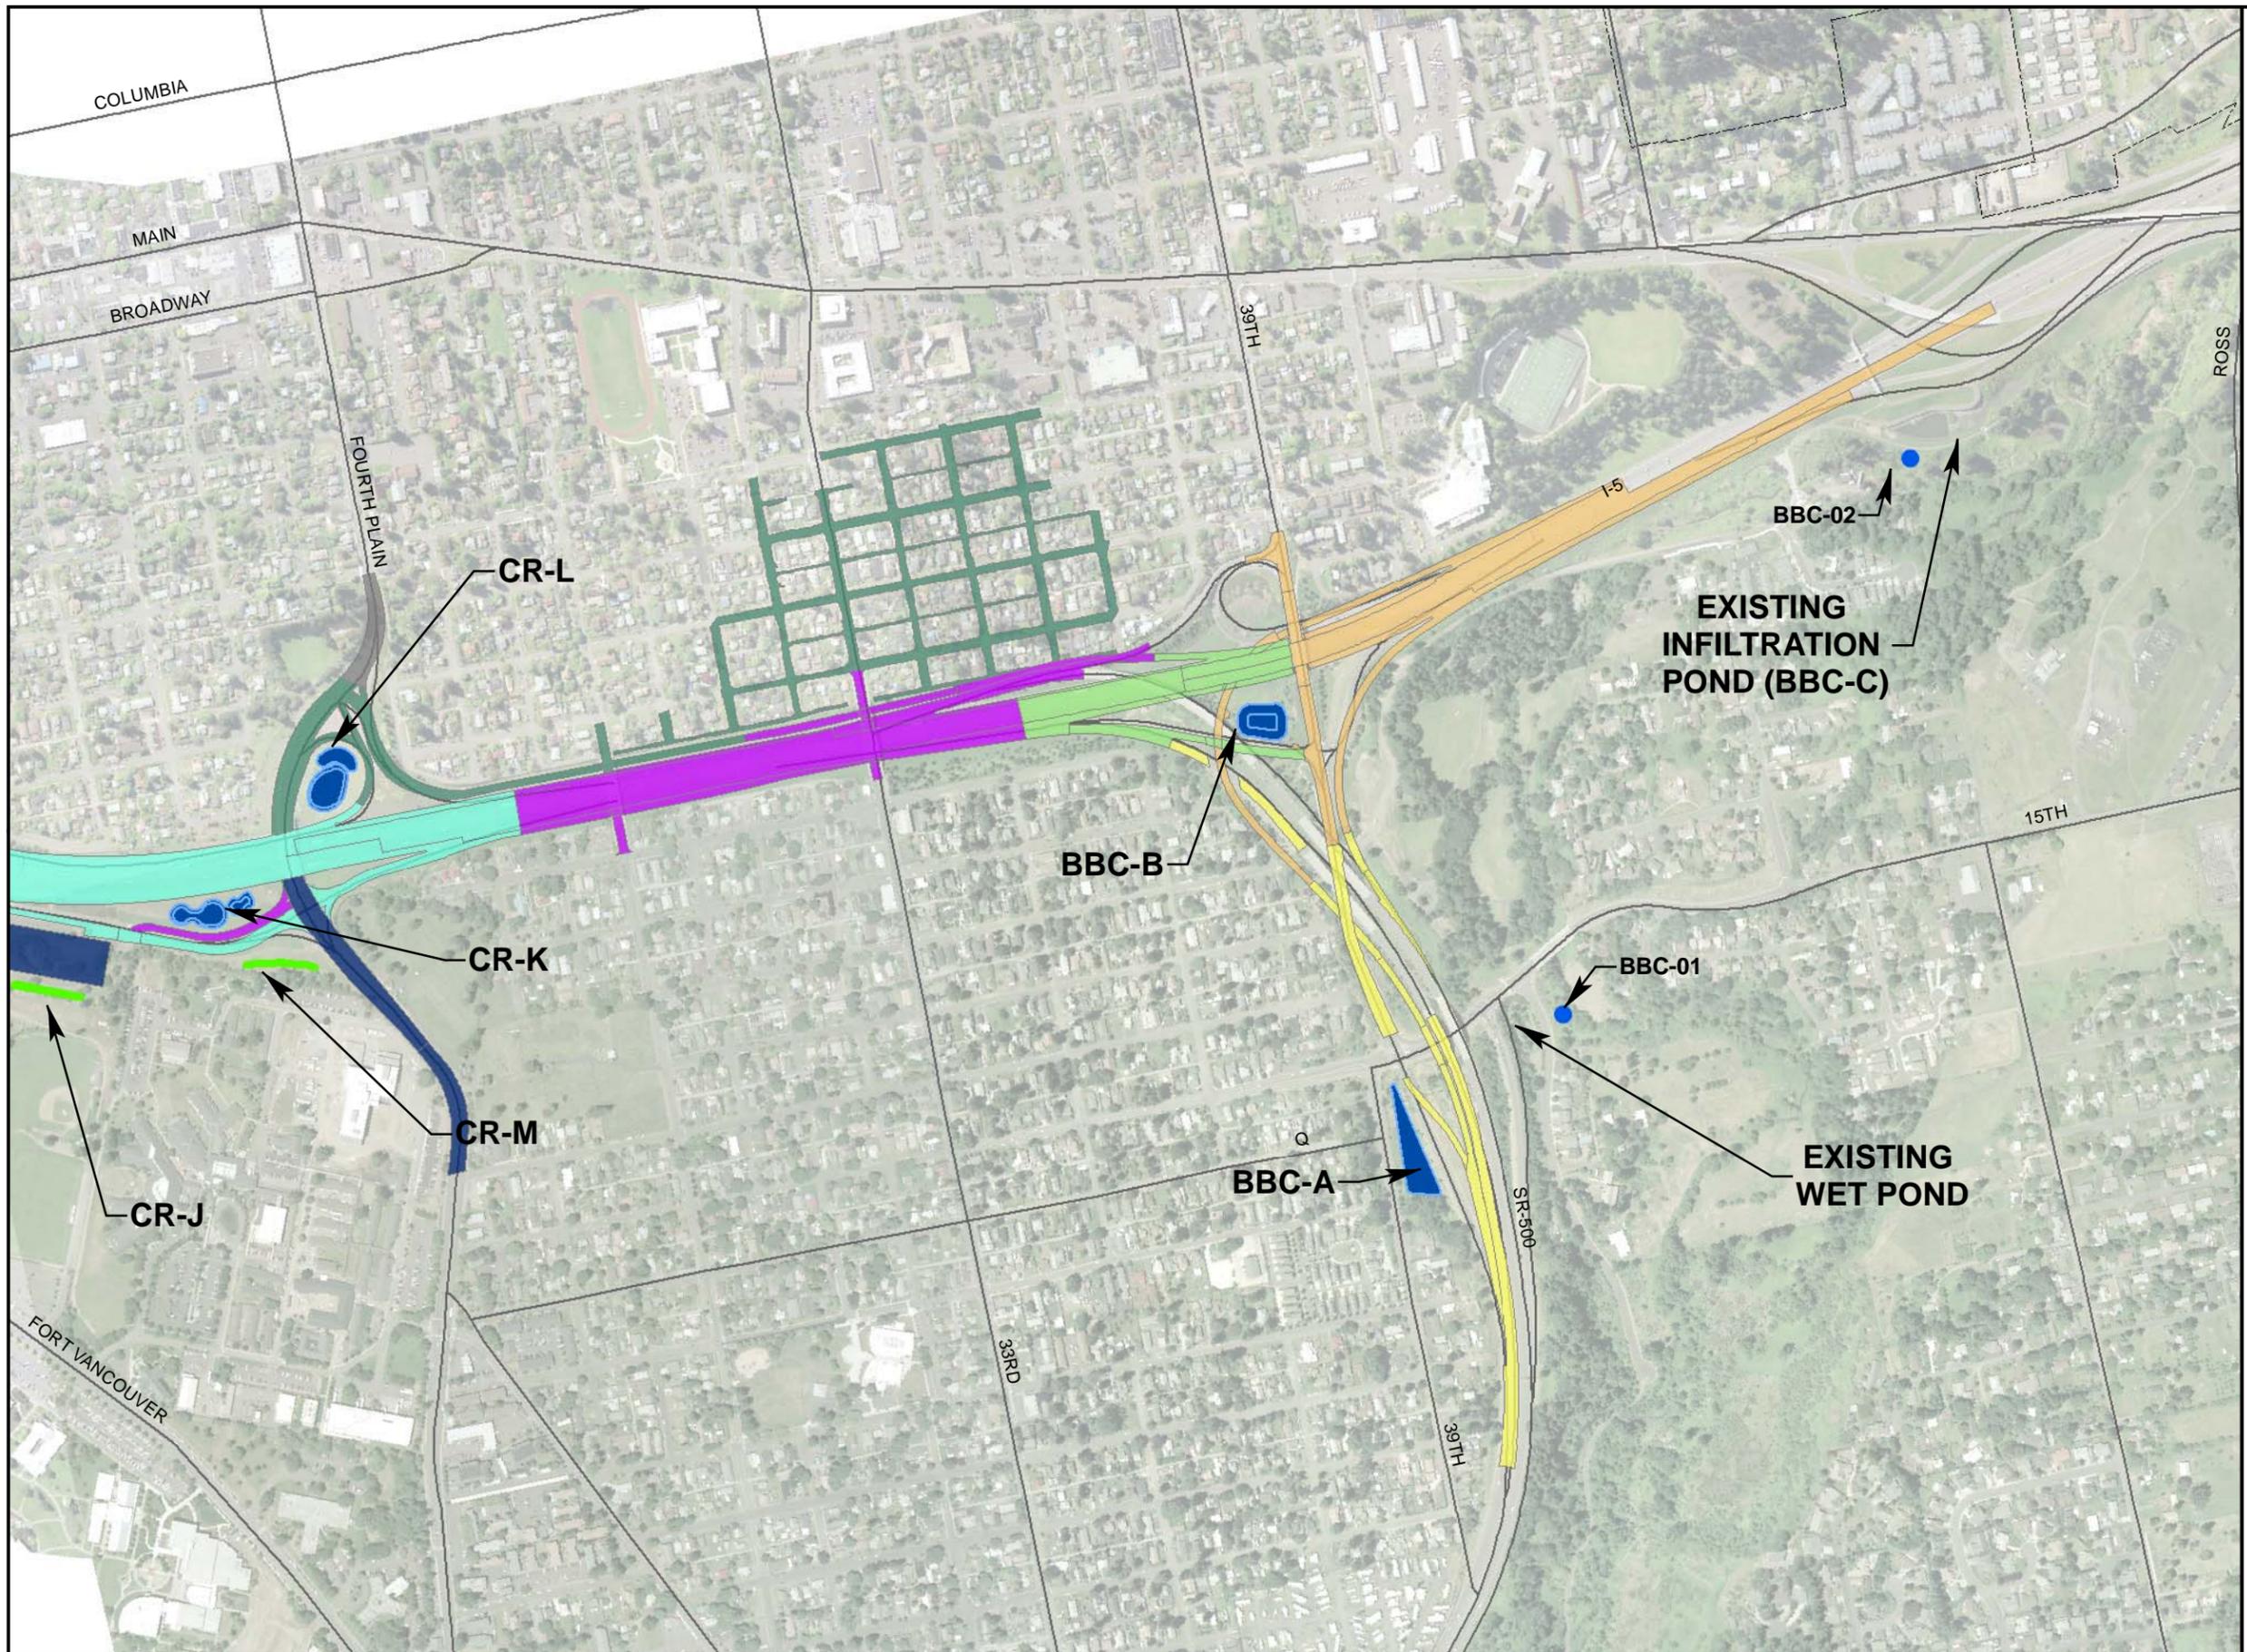
Figure 11.
Proposed Water Management
Facilities - Washington State
(2 of 2)

**Areas Draining to Water
Quality Facilities**

- BBC-A
- BBC-B
- CR-G
- CR-J & CR-M
- CR-K
- CR-L
- Existing Infiltration Pond
- Not Treated

Table 5 summarizes the impact of the project on CIA and the areas from which runoff will be treated, and the paragraphs following the table describe the individual water quality facilities, the locations of which are shown on Figures 10 and 11.

Table 6 summarizes the impact of the project on CIA and the areas from which runoff will be treated, and the paragraphs following the table describe the individual water quality facilities, the locations of which are shown on Figure 11. The table demonstrates that the project proposes to treat runoff from the entire CIA.
